Blind Inlet Fact Sheet

USDA Natural Resources Conservation Service – Iowa

July 2015

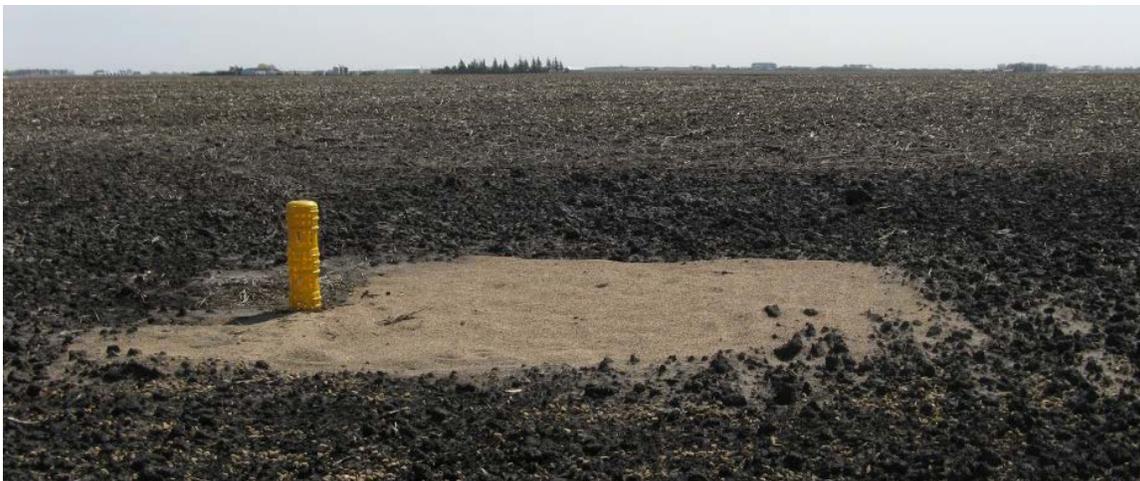
Photo 1. Newly installed blind inlet in Hardin County, Iowa. The perforated riser was left in place for research purposes. (Photo by Martin Shipitalo, ARS-NLAE)

Martin Shipitalo with ARS-NLAE is conducting a study of blind inlets and other practices in the South Fork of the Iowa River in Hardin County. Three blind inlets were installed in early 2014. Mr. Shipitalo reports that “The blind inlets ... slowed infiltration and increased the duration of ponding. Additionally, clogging with fine particles may require removal and perhaps replacement of the sand layer at some sites due to excessive erosion in 2014 that reduced their lifespan.”
