**UNITED STATES DEPARTMENT  
OF AGRICULTURE  
NATURAL RESOURCES  
CONSERVATION SERVICE  
ECOLOGICAL SITE DESCRIPTION**

<b>Site Type</b>	Lotic Riparian Complex
<b>Site ID</b>	058CY001ND
<b>Site Name</b>	Northern Rolling Plains, Northeastern Part, Perennial Riparian Complex (Valley Type VIII, C5 Stream Type)

Northern Rolling Plains, Northeastern Part, Perennial Riparian Complex  
(Valley Type VIII, C5 Stream Type) – 058CY001ND

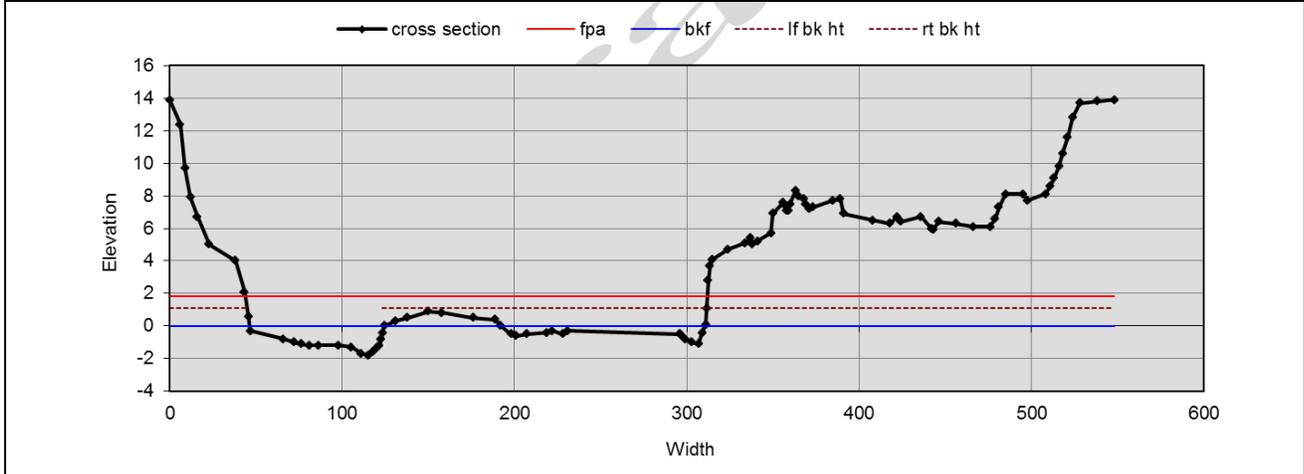
**Figure 2 – Typical valley cross-section.** Valley cross-section of phase 3.2. Note the cut bank on left that indicated incision in the past.

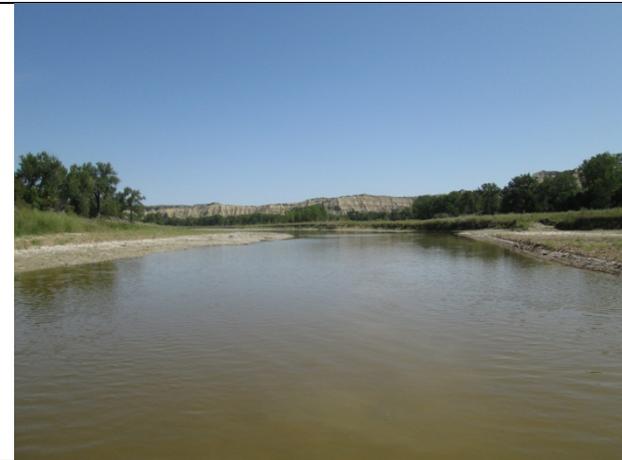
**Photo 1.** Characteristic C5 channel type for the site. Due to decades of disturbances to this system, the best references were found in state 3, phase 3.2.

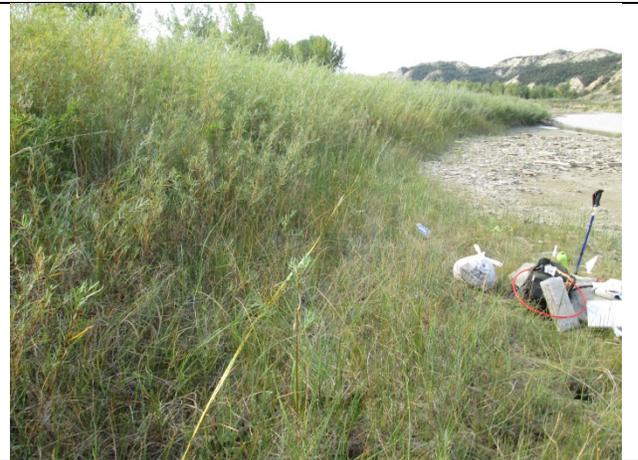
**Photo 2.** Sandbar willows occupy the floodplain steps that receive water and sediments from bankfull events (they can be found in PCC1 and PCC3, but mostly PCC2).

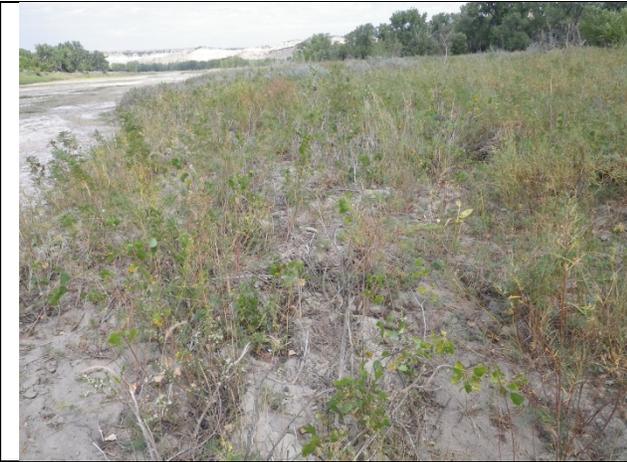
**Photo 3.** Bankfull events create favorable conditions for cottonwood establishment on the floodplain steps (PCC2 and PCC3).

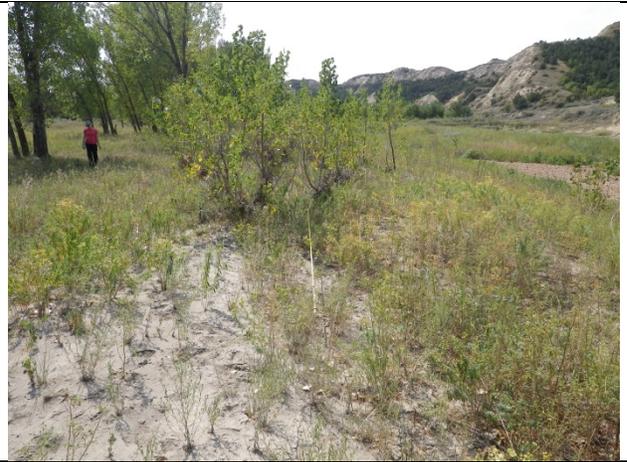
**Photo 4.** Young cottonwoods on the secondary floodplain step.

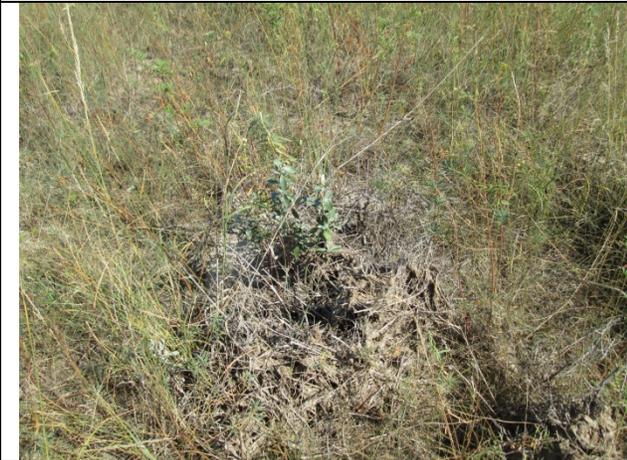
**Photo 5.** Buffaloberry resprouting after being sheared off during a spring flood event (PCC3).

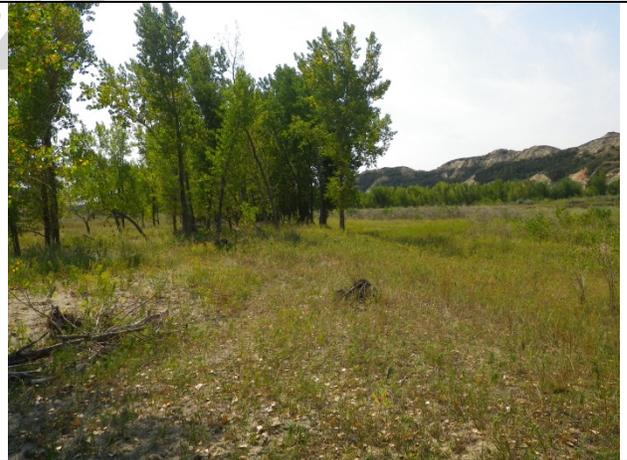
**Photo 6.** Cottonwood gallery of the low terrace (PCC4). The wide valleys of this site support the formation of low terraces.

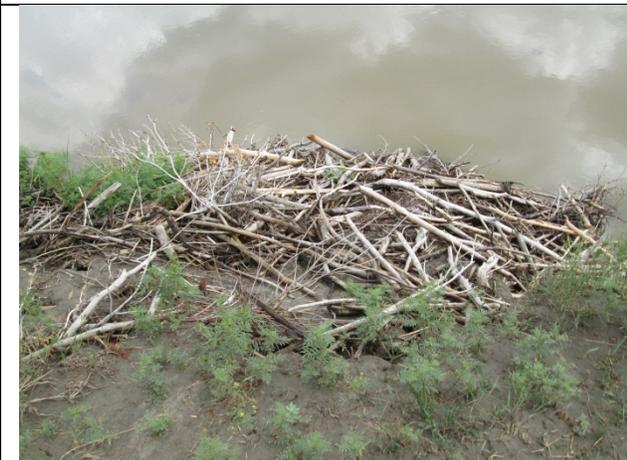
**Photo 7.** Beaver activity helps development of favorable wetland vegetation.

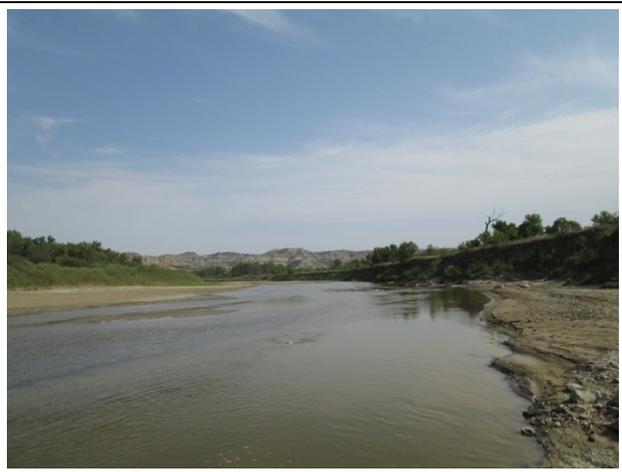
**Photo 2.** F5 channel has flat bottom and near vertical sides: these channels are actively eroding.

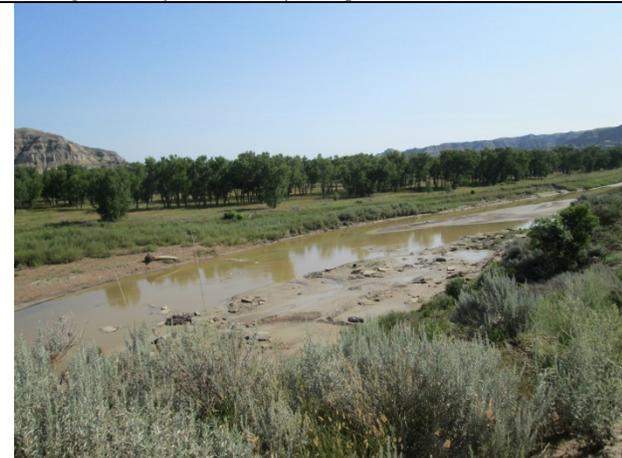
**Photo 3.** The lack of bank stabilizing vegetation results in bank failures causing stable channels to transition into state 2.

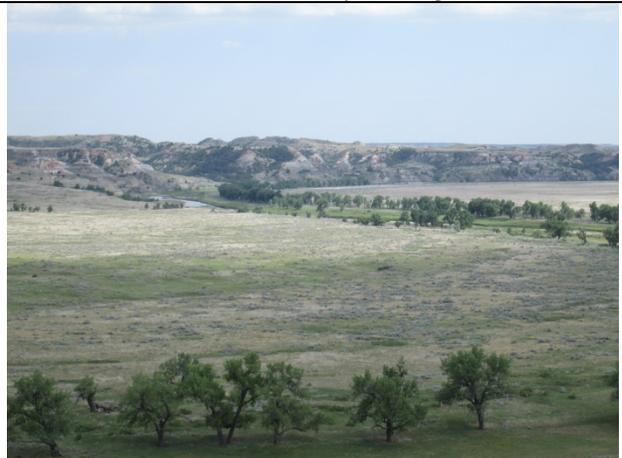
**Photo 4.** The entrenchment of the stream that occurs in state 2 results in the formation of a high terrace that is disconnected from the channel.

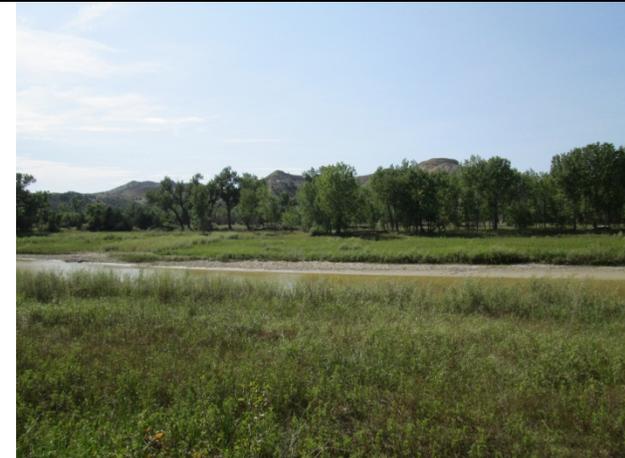
**Photo 3.** B5c channel, phase 3.1, is the most prevalent stable analogue for the site.

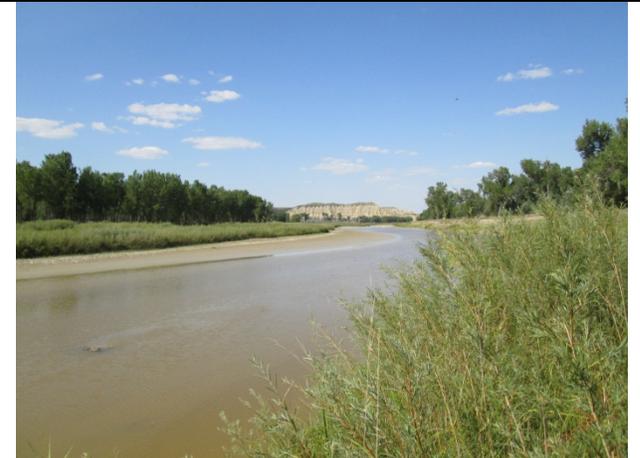
**Photo 4.** In phase 3.1 a new floodplain is established and PCC1 is reestablished.
