Matanuska River Watershed Plan

**U.S. Department of Agriculture
Natural Resources Conservation Service
Palmer Field Office
1700 E. Bogard, Suite 203
Wasilla, AK 99654**

JUNE 2006

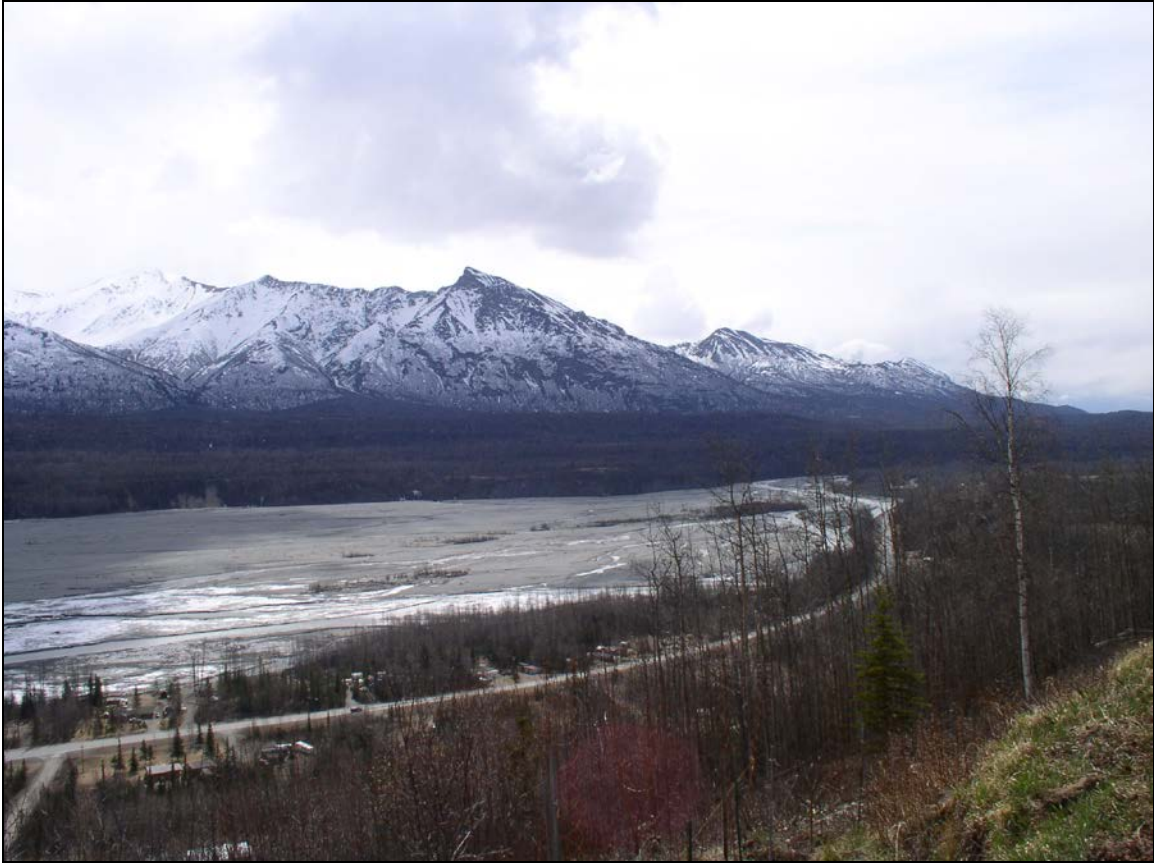
Residential development north of Sutton, Alaska along the Matanuska River. Main channel has migrated to the northern banks. Properties along this reach of the river have lost anywhere from 10 to 50 feet of property in one event.
