BIOENGINEERED STREAMBANK STABILIZATION ON ANDERSON CREEK: A Case Study

TN - FORESTRY - 40

September 1994

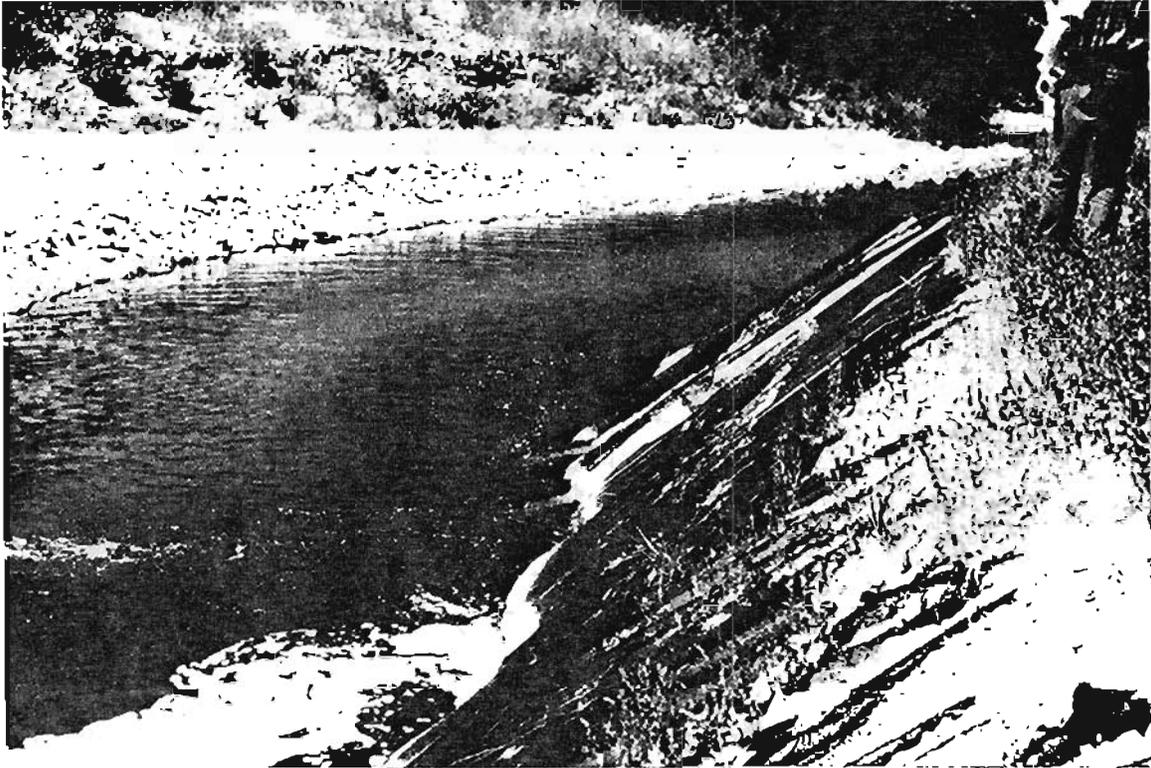
1. Newly constructed jetty with geotextile and gravel

Bioengineered streambank treatments were installed in November, 1988. The east bank was graded to a 6:1 slope, with the west bank retained at the existing 1:1 slope. Three jetties were constructed into the creek from the east bank. The jetties were eight feet high and constructed of gravel from the site. The gravel was wrapped and anchored with a geotextile material to reinforce the jetties and keep the gravel in place (See Photo #1). The gravel was used to replace imported rock rip-rap to minimize cost. Some rock was used later, however, to armor the upstream side of the jetties (See Photo #3). Time to design the 1,000 foot project was 280 hours with construction time totaling 3.5 weeks.

For the geotextile material to be effective, it was installed to totally cover the front, top and back sides of each jetty. If only a partial coverage is used, the effectiveness of the jetty is severely diminished.

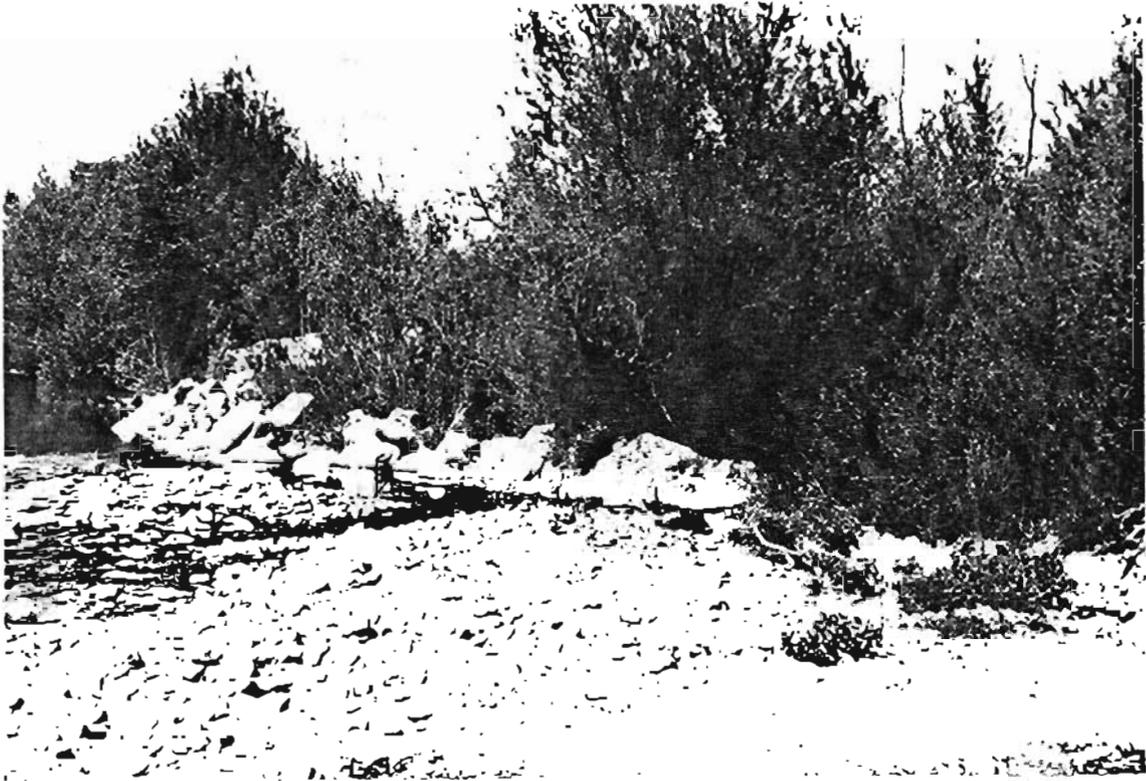
3. Vegetated and armored jetty April, 1994

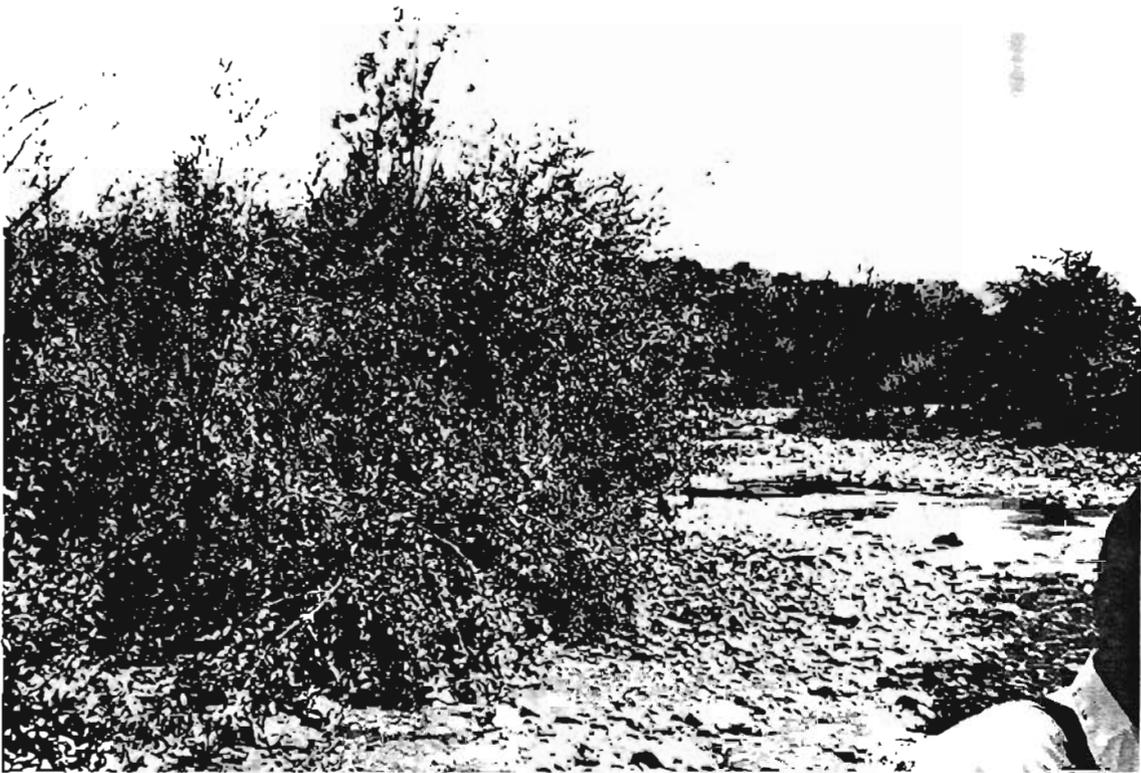
4. Vegetated area in accumulated sediment behind jetty

The jetties were designed to divert high water away from the fill material along the east bank (See Photo #2), keeping the main channel along the stable west bank. Another objective of the design was to create eddys behind the jettys to facilitate deposition of silt over the gravel to produce a medium favorable to plant establishment (See Photo #4).

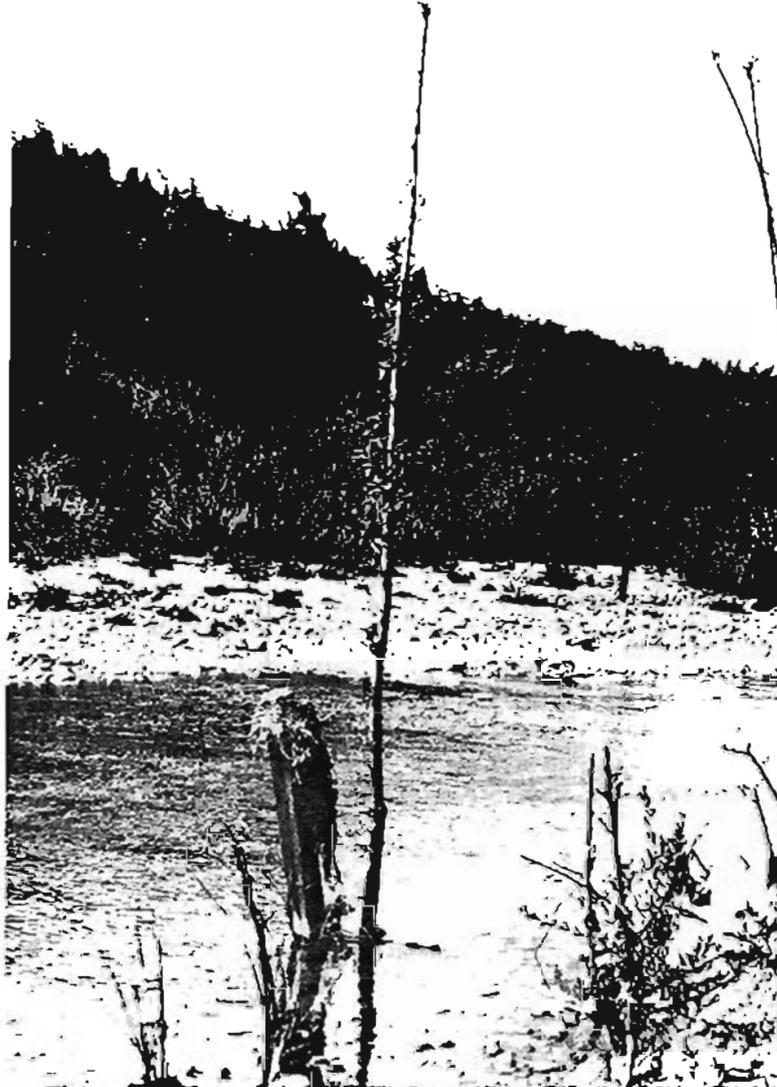
5. Poles standing
in stream soon
after
establishment

Vegetative establishment has consisted of an integrated program of planting seedlings, various sizes of cuttings, and natural (on-site) vegetative and seed propagation from willows and poplars. Pole-size cuttings of willow were planted to a depth of five feet with a tractor mounted auger at the edge of the re-established stream channel (See Photo #5). This has helped maintain the channel during peak flows. These large cuttings have been integrated with willow wattles placed horizontally in contact with the sediment trapped in the eddys (See Photo #6). This has allowed the wattles to also sprout (See Photos #8 through 10). All methods of propagation have been successful. Initially, small cuttings and seedlings were planted to get cover established.

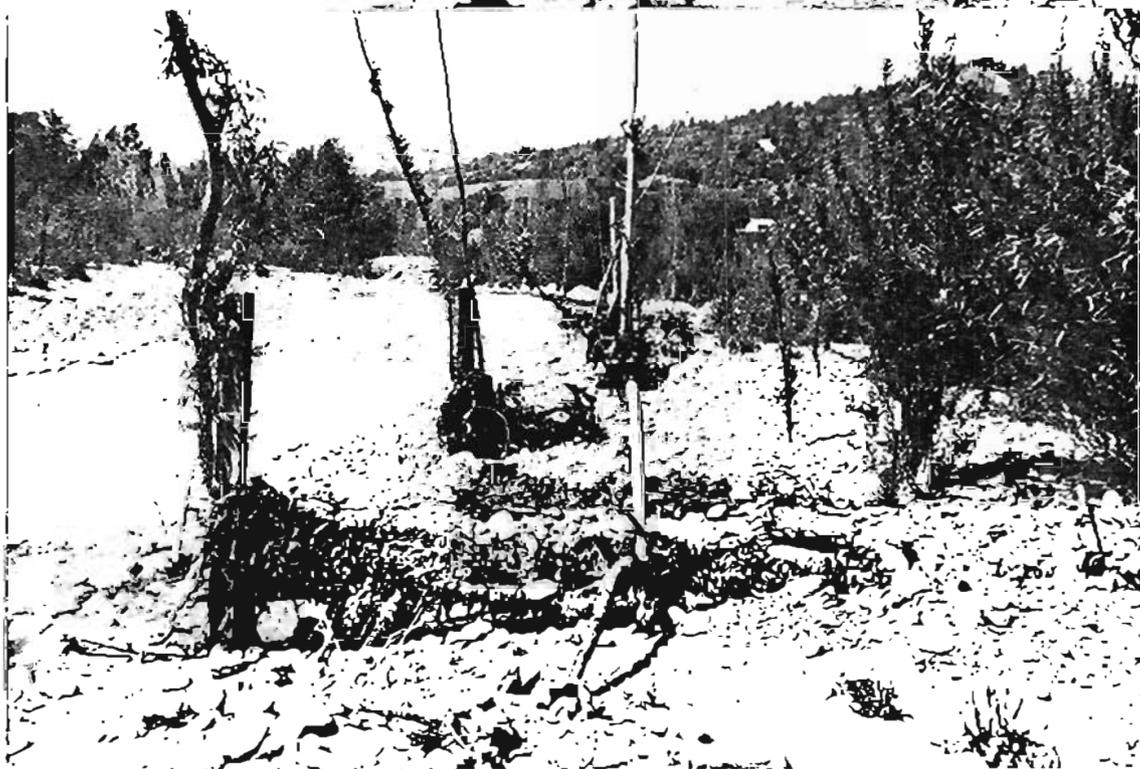
6. Poles with wattlings sprouting through the sediment

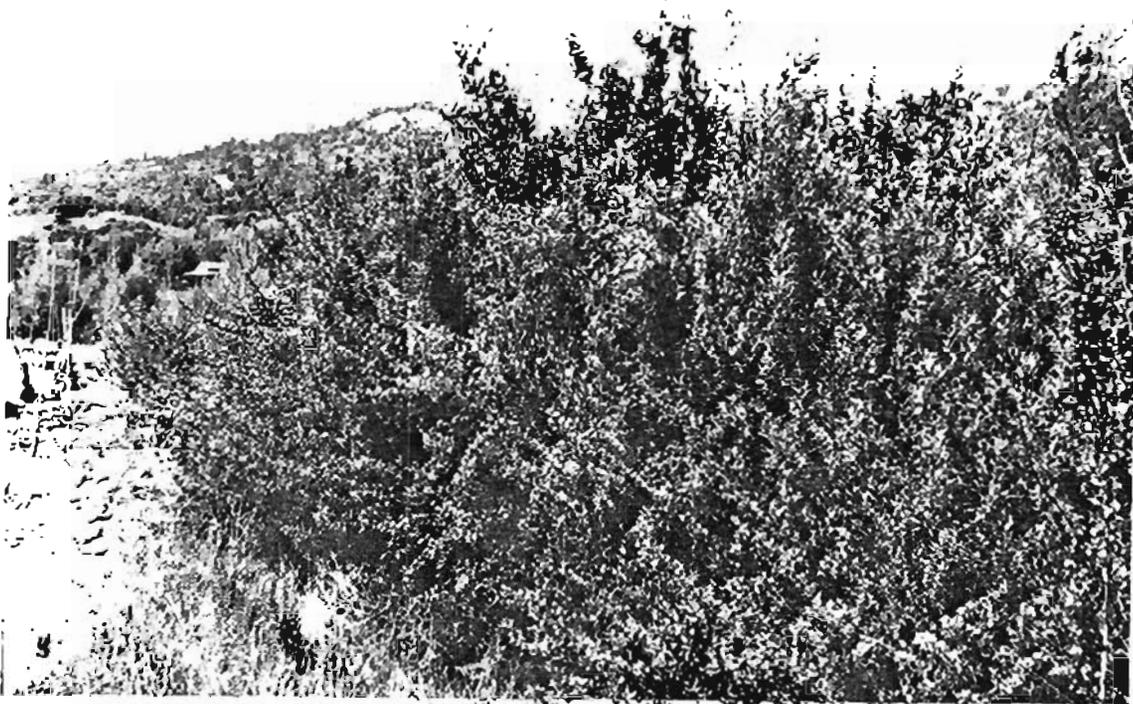
7. Established willows

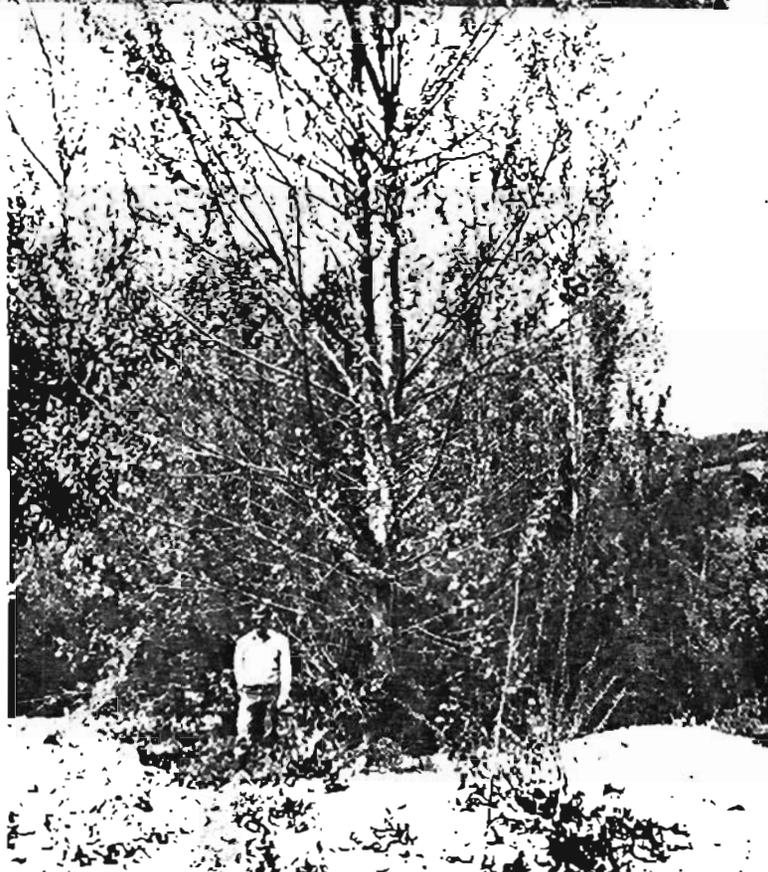
8. Mixed arborescent and brushy willows showing diverse riparian habitat

The vegetative portion of the treatment was an aggressive plant establishment program consisting of species of willow (*Salix spp.*) and poplar (*Populus spp.*). The success of this project is linked directly to the land owner's efforts in plant establishment. Specific species are not as important as the mix of brushy forms and arborescent forms of willow and poplar.

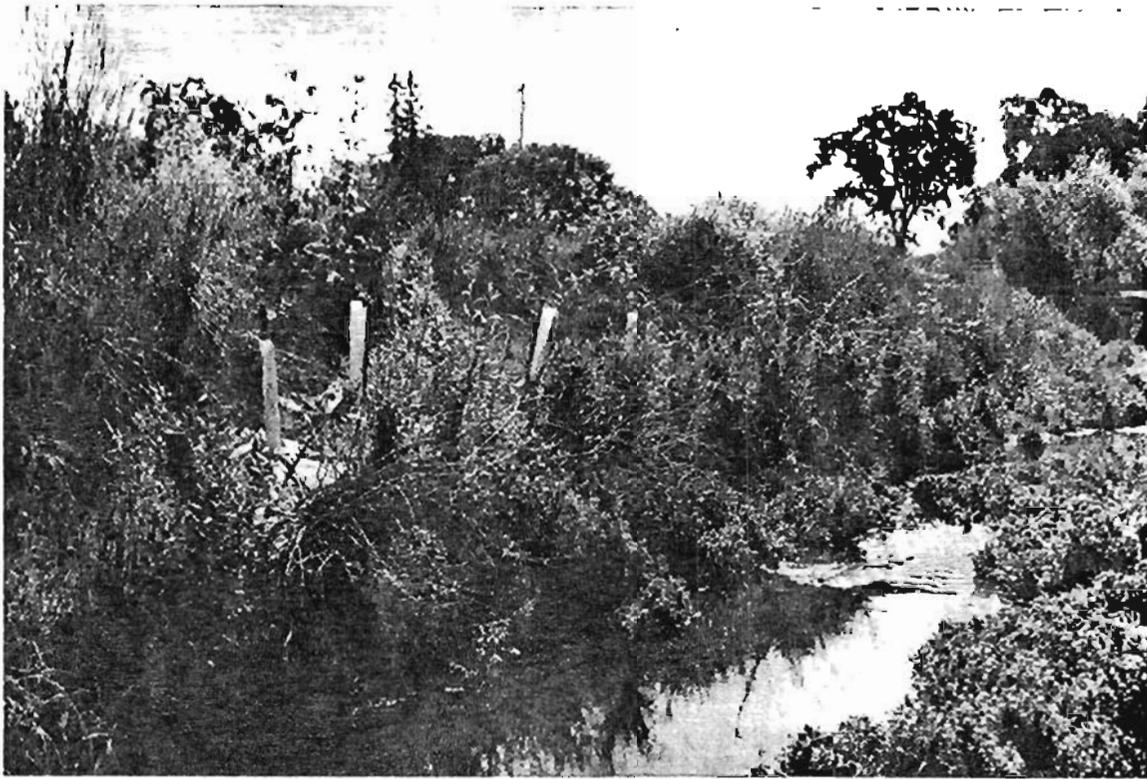
9. Woven willow live revetment
