## ***CASE STUDY***

### **Conservation Practice Standard: Waste Storage Facility Code 313 Slotted Dewatering Fence in Corner of Pit, Albion, Kennebec County.**

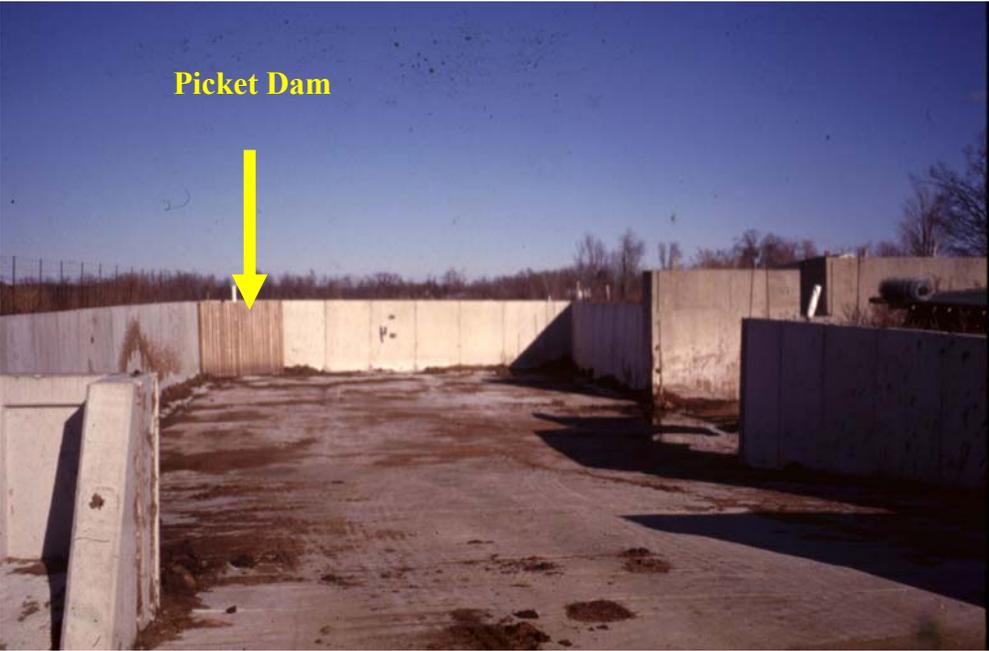
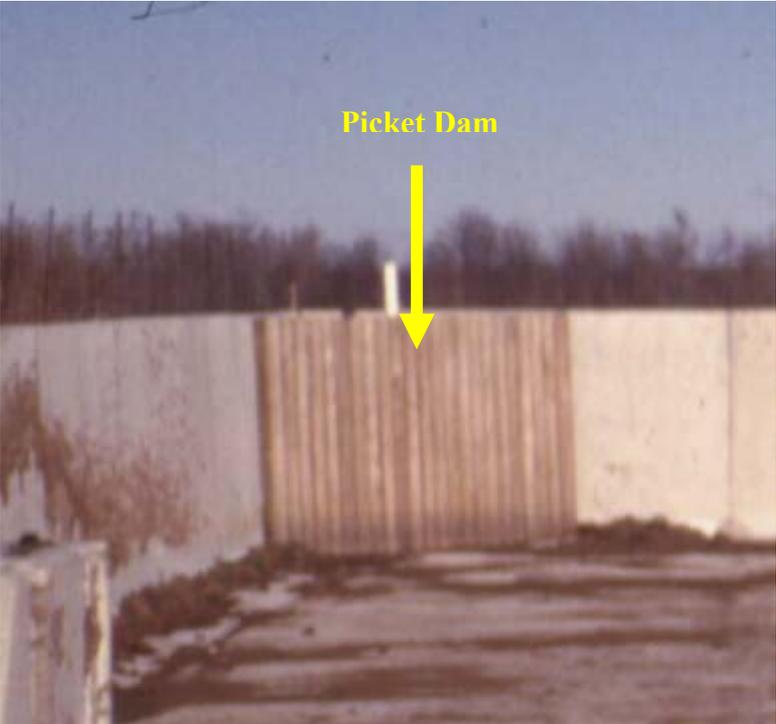
Picket dams have long been used to drain runoff from manure storage areas while retaining the solid manure and bedding within the storage area, enabling manure to be handled as a solid. The two dams in the McKeen pit were situated behind one stabilizing wall on the existing pit, adjacent to the ramp, and at the far corner of the newly constructed pit. The dam adjacent to the ramp keeps liquids away from the bottom of the ramp, which would interfere with the bucketing of the manure. The picket dams are 12 feet long by 8 feet high. Each are made with 4 pressure treated lumber beams, and decked with 1-inch thick hemlock boards,  $\frac{3}{4}$ -inch apart. The bottom beam, set one-foot off the floor is 10"x10", 2 feet above is the next beam (10"x10"), and the next succeeding two-foot intervals are an 8"x8" and a 6"x6" beam, respectively. The dams are engineered to withstand loads of a full pit of manure and the worst case scenario of the dam plugging up. Behind each of the dams is a 4-inch diameter PVC Schedule 40 elbow placed at the floor surface, connected to the same diameter and schedule pipe, sloping at 1% out to the filter area. During the winter months a 4-inch diameter, 10-foot long removable riser sits in the elbow, working as a stopper. Two weeks prior to unloading the pit in the spring the solid riser will be removed, draining the liquids accumulated in the pit and into the filter area, capturing the peak nutrient-uptake of the filter area grasses. Each of the dams is removable to allow for ease of cleaning.

The McKeens' decision to enclose the existing pit presented another choice – how to maintain the consistency of the manure coming out of the barn in order to continue to handle the manure as a semi-solid. The addition of any rainwater would require that the manure be handled as a liquid. The objective became how to eliminate or remove an average of 1.5 feet of precipitation (after subtracting annual evaporation) each year from a pit totaling 80,000 gallons. A roof was decided against due to cost (\$4 per square foot for a 7,200 square foot pit), thus a situation presented itself to remove the excess water using the old technology of picket dams in a new way. Working with the McKeens, NRCS designed an expansion to the existing pit and two picket dams to remove accumulated liquids. Each of the 8'x12' picket dams cost \$1,000 at time of construction – a considerable difference from the cost of a roof.
