CASE STUDY

Conservation Practice Standard: Animal Trails and Walkways Code 575 Boat Ramp Stream Crossing in Unity, Waldo County.

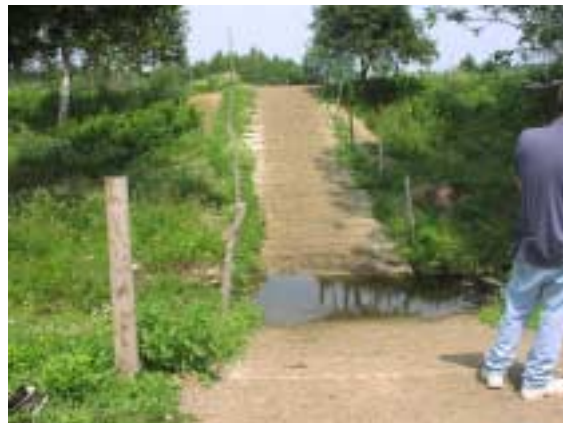
Before installation of the boat ramp panels, the land surface is first graded and smoothed. Geotextile fabric is laid on the surface and over topped with a minimum of 2 inches of sand. The panels are put in place and bolted together such that the panels are hinged which provides a lot of flexibility. This flexibility allows the assembled panels to follow a rolling terrain and survive freeze-thaw situations. For this site, 50 panels were used covering a linear distance of 75 feet. The boat ramp system extends from level ground on one side of the stream, down the bank, across the

stream, and up the bank to level ground on the other side. The steepest approach is 6 (H) to 1(V). The boat ramps were installed slightly below the original stream bottom. A thin layer of stream bed material has covered the boat ramps giving the stream bed a natural appearance. Small fish were seen swimming across the boat ramps during a site visit in July.

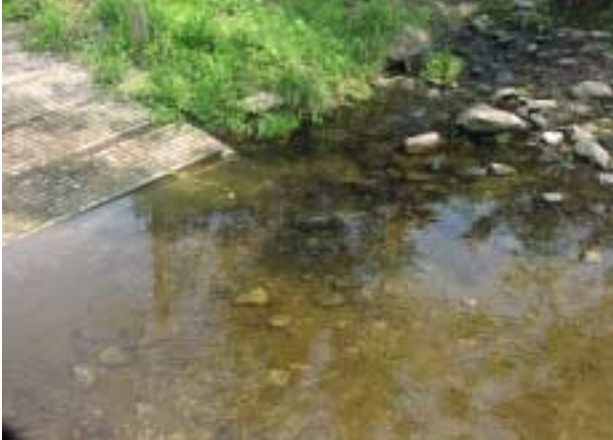
A two strand electric fence has been installed on each side of the crossing to confine cows to the crossing. The stream banks on both sides have been fenced off. The stream bank has become re-vegetated. About 600 spruce and red pine were planted along the stream banks to re-establish the riparian buffer along with natural re-vegetation. Each boat ramp panel costs about \$100 installed. Total cost of this project is around \$7000.
