United States Department of Agriculture
Natural Resources Conservation Service

Animal Enhancement Activity –ANM18- Retrofit Watering Facility for Wildlife Escape

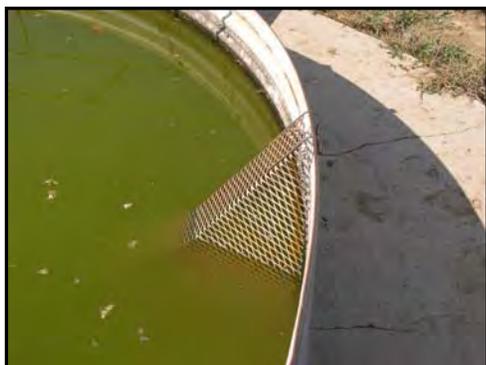
Retrofit existing watering facilities (troughs, tanks, etc.) to allow for the escape of wildlife that become trapped while trying to drink.

- Extend into the water and meet the inside wall of the trough
- Reach to the bottom of the trough
- Be firmly secured to the trough rim and to the bottom of the trough so as not to be displaced by livestock
- Be built of grippable, long-lasting materials, such as painted or coated metal grating, roughened fiberglass, concrete, rock and mortar, or high-strength plastic composites.
- Have a slope no steeper than 45 degrees
- Be located to cause minimal interference with livestock
- One structure for every 20 linear feet of trough edge.
